DEPARTMENT OF TRANSPORTATION**DIVISION OF ENGINEERING SERVICES**

Office of Structural Materials

Contract #: 04-0120F4Cty: SF/ALA Rte: 80 PM: 13.2/13.9File #: 1.28**WELDING INSPECTION REPORT****Resident Engineer:** Casey, William**Address:** 333 Burma Road**City:** Oakland, CA 94607**Report No:** WIR-028913**Date Inspected:** 14-Dec-2012**Project Name:** SAS Superstructure**OSM Arrival Time:** 700**Prime Contractor:** American Bridge/Fluor Enterprises, a JV**OSM Departure Time:** 1730**Contractor:** American Bridge/Fluor Enterprises, a JV**Location:** Job Site**CWI Name:** Andrew Keech**CWI Present:** Yes No**Inspected CWI report:** Yes No N/A**Rod Oven in Use:** Yes No N/A**Electrode to specification:** Yes No N/A**Weld Procedures Followed:** Yes No N/A**Qualified Welders:** Yes No N/A**Verified Joint Fit-up:** Yes No N/A**Approved Drawings:** Yes No N/A**Approved WPS:** Yes No N/A**Delayed / Cancelled:** Yes No N/A**Bridge No:** 34-0006**Component:** SAS Tower**Summary of Items Observed:**

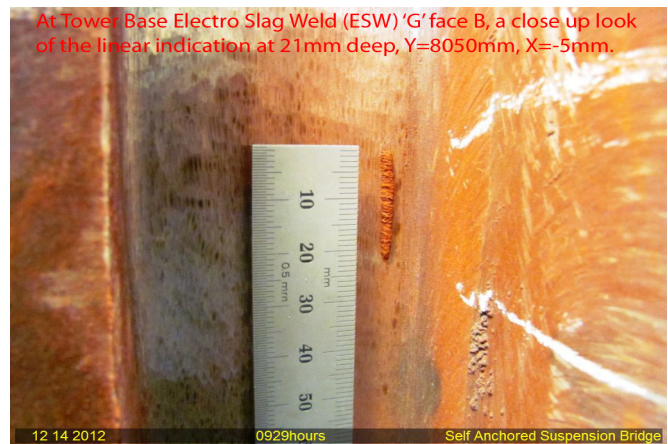
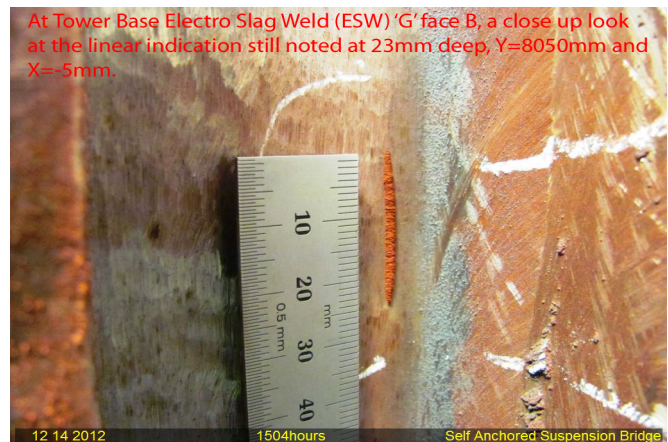
At Tower Base Electro Slag Weld (ESW) 'G' weld joint #S-045 face B, ABF personnel was observed continuing to perform exploratory excavation on welded ESW at location Y=8030mm due to UT detected defect. The ABF personnel have resumed the exploratory excavation from 20mm deep where ABF personnel have left off yesterday.

The personnel were noted using only the disc grinder in every 1mm increments of excavation. ABF QC Andrew Keech was observed performing Magnetic Particle Testing (MT) on the following various depths with two noted linear indications. This QA also performed the same test and noted same result. During the shift, the ABF personnel continued the excavation in 1mm increments using the same method of test and verification up to 23mm with same result. The excavation was completed up to this point and will resume from this point at the next scheduled shift.

1. 21mm in depth – one 22mm long linear indication noted at Y=8050mm, X=-5mm
2. 22mm in depth – one 30mm long linear indication noted at Y=8050mm, X=-5mm and one 2mm long linear indication at Y=7930mm, X=-12mm.

3. 23mm in depth – one 30mm long linear indication noted at Y=8050mm, X=-5mm and the other 2mm long linear indication has been removed.

At Tower Base Electro Slag Weld (ESW) 'V' weld joint #W-043 face B, ABF personnel was observed continuing to perform exploratory excavation on welded ESW at various Y locations; Y=1030mm, Y=1055mm, Y=1090mm, Y=1100mm and Y=1130mm due to UT detected defects. The ABF personnel have resumed the exploratory excavation at 63mm deep wherein ABF QC Jesse Cayabyab wants the width of the weld cover (35mm wide) to be the same width at the bottom of the excavation at 63mm. The width of the excavation at 63mm deep was originally measured at 25mm. The personnel were noted using only the disc grinder in widening the width of the excavation. The widening of the excavation was completed and ABF QC commence the MT which was not completed during this shift.
